Underground Storage Tank Assessment Report dated 22 May 1998

Quarters "W" Housing (Site Identification # 15405-General File) Charleston Naval Complex/Charleston Naval Base

Enclosed are the Assessment Reports for the closure of Underground Storage Tanks D, J, O, P, Q, R, S, T and W located at the Charleston Naval Complex, Charleston, SC.

South Carolina Department of Health and Environmental Control (S.C.D.H.E.C.) Underground Storage Tank (UST) Assessment Report

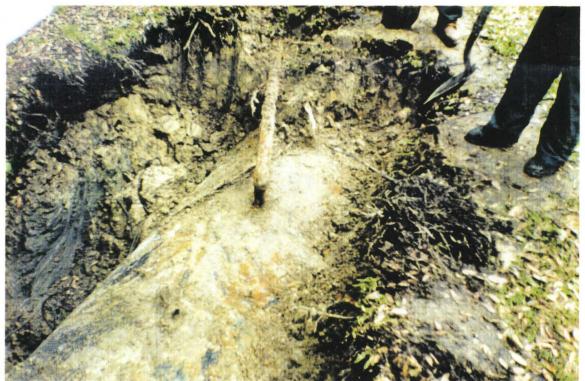
> UST Quarters W was covered with a protective coating of pitch. The tank was in sound condition and contained no holes.

Photo 1: UST Quarters W exposed for removal.

UST Quarters W was removed, drained, cut open at both ends, and cleaned with a steam cleaner. It was then cut up for recycling as scrap metal. (See Attachment III.)

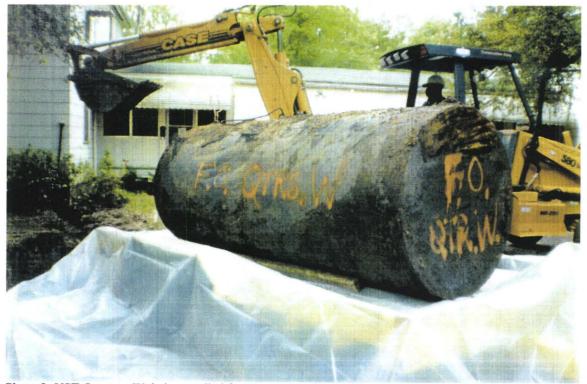
Photo 2: UST Quarters W being readied for transport to the cutting pad.
